## Building Abstract

### Headquarters

### Building 1

**Structure Number:** 1  
**Original Use:** Headquarters for N.W. Branch of the National Home  
**Present Use:** Veteran's Service Offices  
**Construction Date:** 1895  
**Architect:** Unknown  
**Number of Levels:** Three (including basement)  
**Total Area:** 17,600 square feet  
**Plan Shape:** Squared off "C"  
**Basic Construction:** Wood floor joists, masonry bearing walls  
**Uses per Floor:**  
Basement -  
9 Storage rooms, 2 Toilets, 1 Stairway  
First Floor -  
Lobby, 12 Offices, 2 Vaults, Janitors Closet and Toilet Room, 1 Stairway  
Second Floor -  
Bath, 5 Closets, Men's Toilet, 12 Offices, Conference Room, 1 Stairway

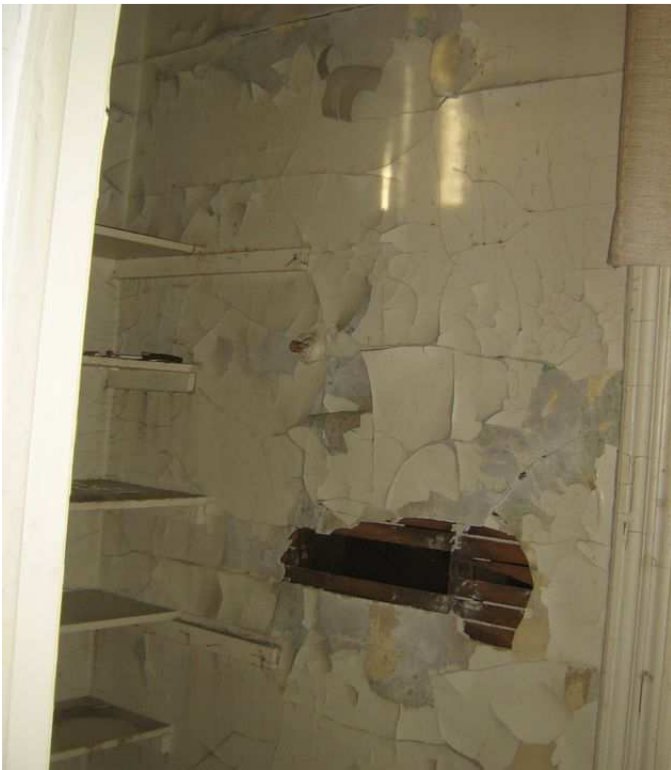
**3** *Damaged plaster.*

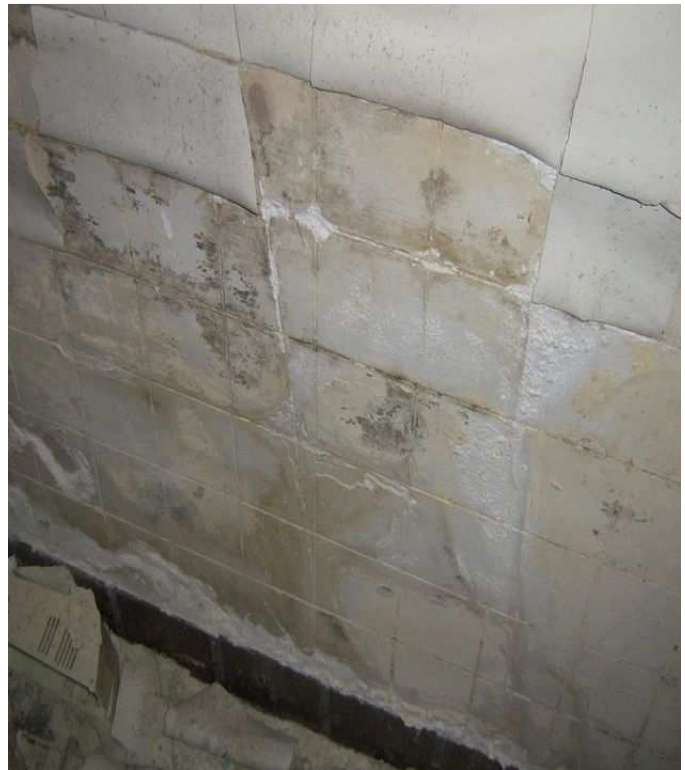
**4** *Damaged brick mortar and suspect mold growth on wall.*

Suspect mold growth and stained building materials implies that there is or has been water intrusion or leaks or the relative humidity within the building was high enough to cause localized or widespread condensation. It is recommended that the moisture source be located and corrected, if this has not already taken place, remove fungal-impacted building materials, and replace or repair the water stained materials.

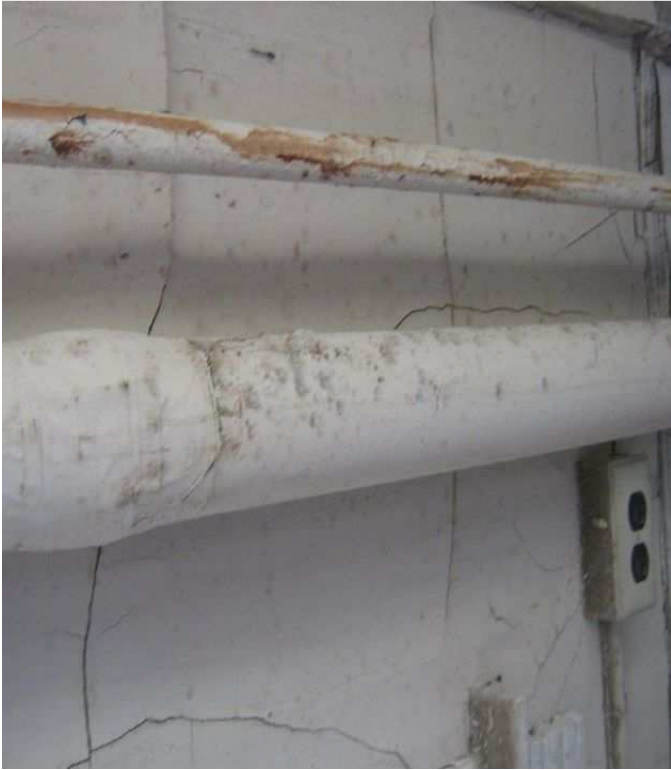
**5** *Damaged thermal insulation and suspect mold growth.*

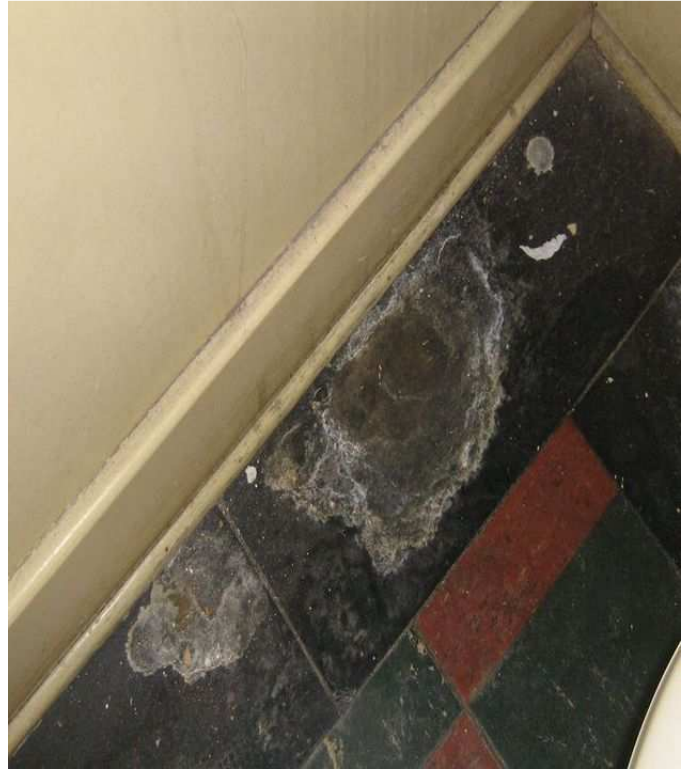
**6** *Worn, damaged floor tile and water-stained wall.*

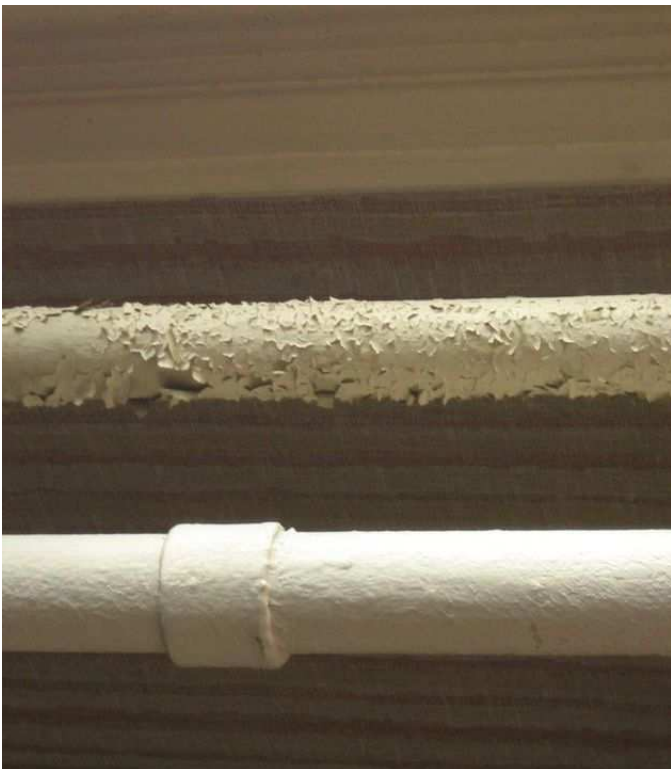
**7** *Peeling paint on pipes.*

Paint which has begun to peel due to a failure of the bond to the wood, plaster, or metal substrate should be removed. Paint is best removed with the careful use of metal scrapers. Sanding is usually required to eliminate rough surfaces and to smooth the transition between areas of raw wood and solid original painted surfaces. Before repainting, all raw surfaces should be primed with a tested and approved primer. This treatment should then be followed by required coat(s) of paint of the type and color to match the surrounding area. All activities must be conducted in a manner consistent with the requirements provided in 29 CFR 1926.

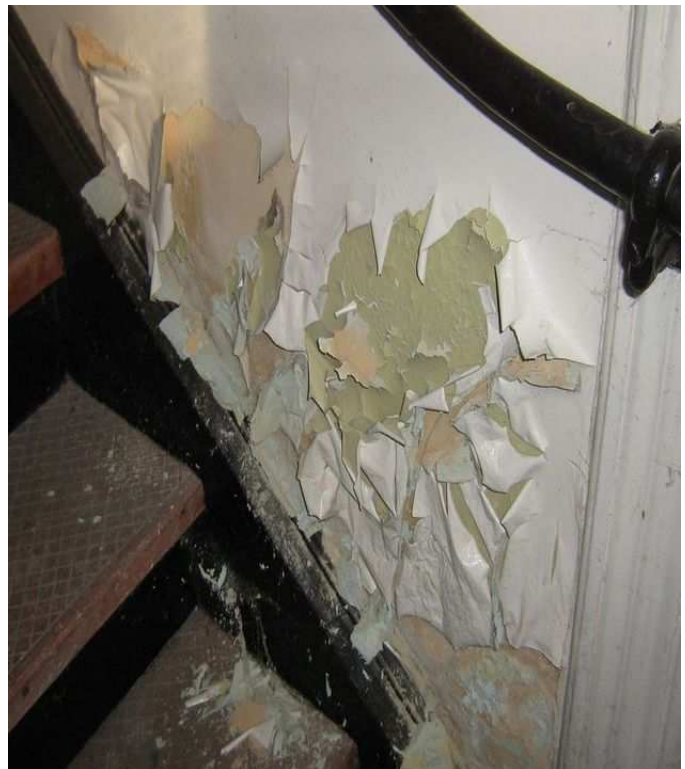
**8** *Peeling paint on walls.*

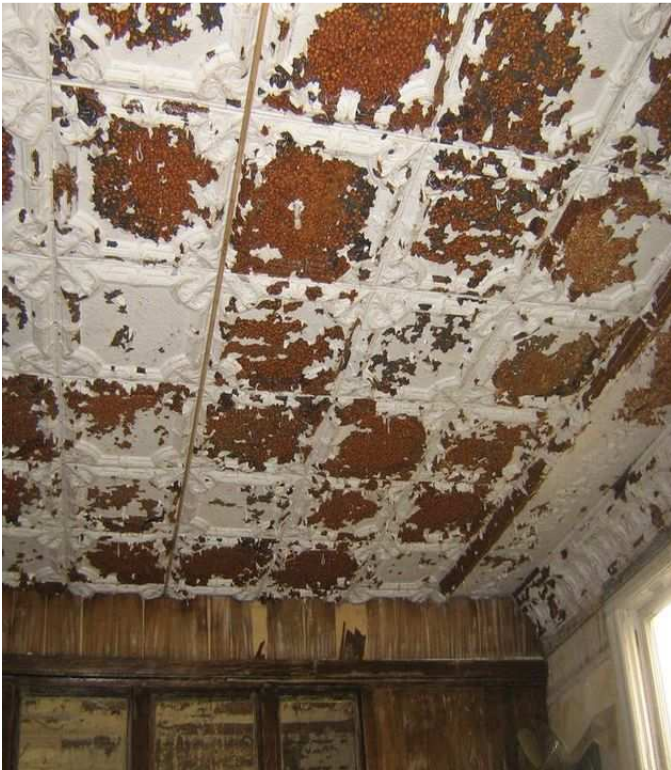
**9** *Peeling paint on ceiling.*

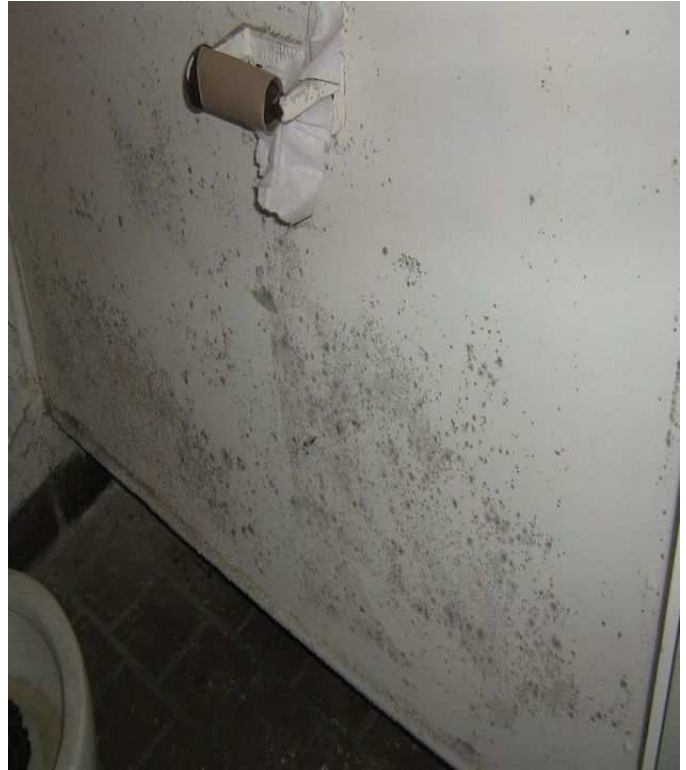
**10** *Suspect mold growth on wall.*

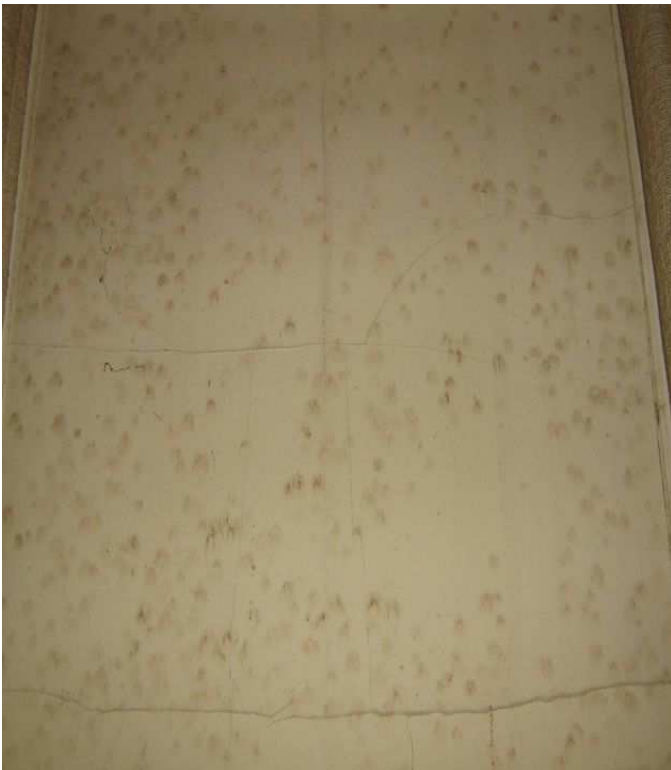
**11** *Suspect mold growth on wall.*

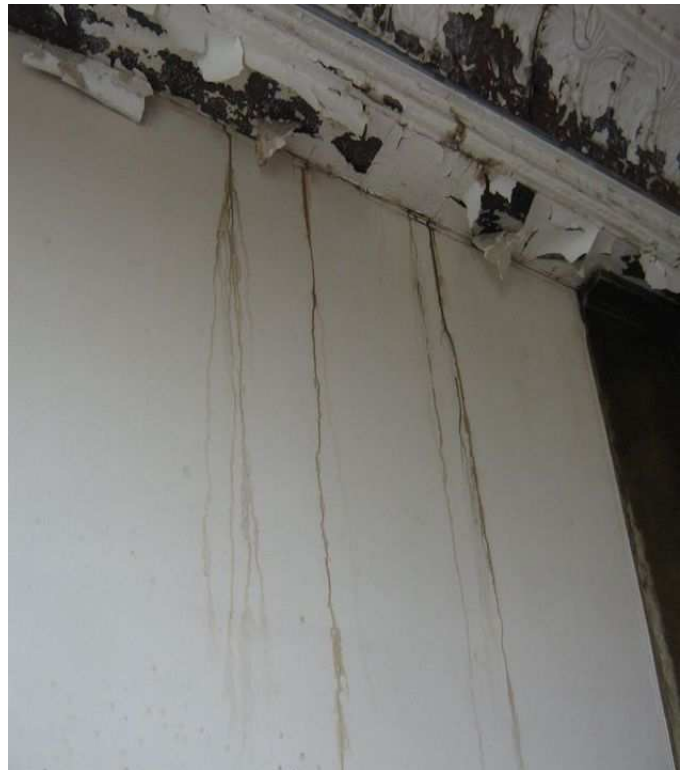
**12** *Water-stained material and peeling paint.*
